CASE STUDY – *Palace of Westminster, Subway Development*

Parliamentary Works
Directorate

2000-2004 Programme of
Works & Maintenance

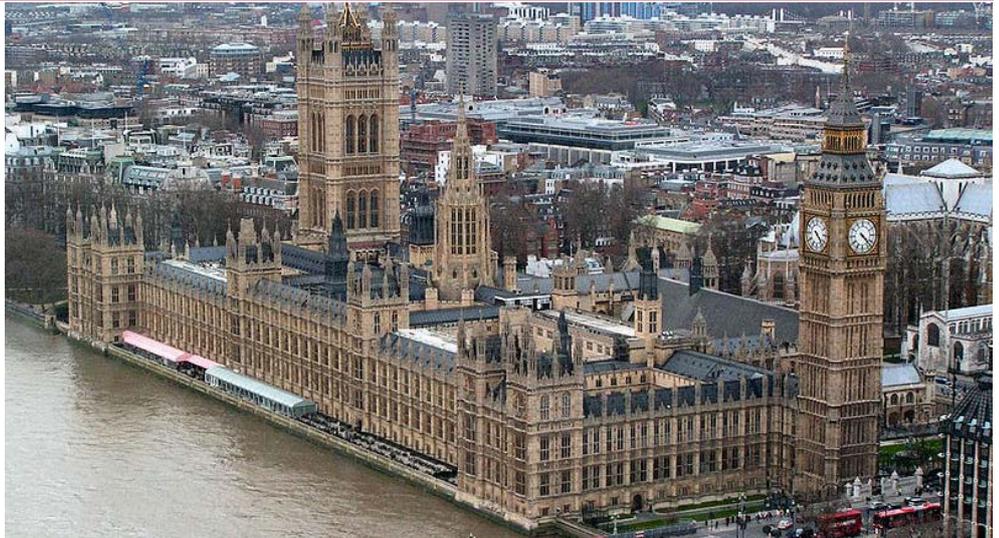
Following the Jubilee line extension works there was a requirement to develop the existing Palace subway network. This included the formation of an enlarged tunnel running underneath Big Ben to Portcullis House. The original 150 year old access tunnel, running approximately 1m beneath the main road, rendered unsafe from the effects of high volumes of traffic.

Stonewest utilised surplus materials previously used on other aspects of the Palace and which had been in long term outdoor storage. These salvaged Ketton stones were cleaned, re-worked and then assembled, like pieces from a large jigsaw, to form the basis of the new vaulted ceiling. A delicate operational process followed.

- Utilising screw jacks and head trees, the individual pieces were fixed in place. Fractured stones were pinned and secured with resin. Hydraulic lime mortar repairs and re-pointing were carried out to existing parts of the tunnel walls and detailing.

- Supports and moulds for the vaulted ceiling were made up and fitted within the tunnel and the stonework was fixed in place and dry packed as opposed to grouting.

- Our stonemasons suggested that ancient methodology would provide the desired results and so a plan was agreed. The stones were all fixed and packed in place and thereafter all the screw jacks and supports were loosened. The walls and floor of the tunnel was given suitable protection. All screw jacks were roped together and the ropes extended either end of the tunnel.

- All non essential personnel were removed from the area and the entrances cordoned off. The ropes were pulled from both directions simultaneously and all screws jacks and supporting materials fell away at the same time leaving the stonework in place. This method was carried out to achieve a consistent level of the ceiling throughout as opposed to risk any single stone settling lower than others if single screw jacks were loosened.

- All stones to the vaulted ceiling stayed in place and the tightly packed joints were re-pointed and all stones were subsequently grouted following the set of the pointing.
