CASE STUDY – *Victoria Palace Theatre*

Victoria Palace Theatre

Christopher Steadman
Architects

Stonewest Ltd

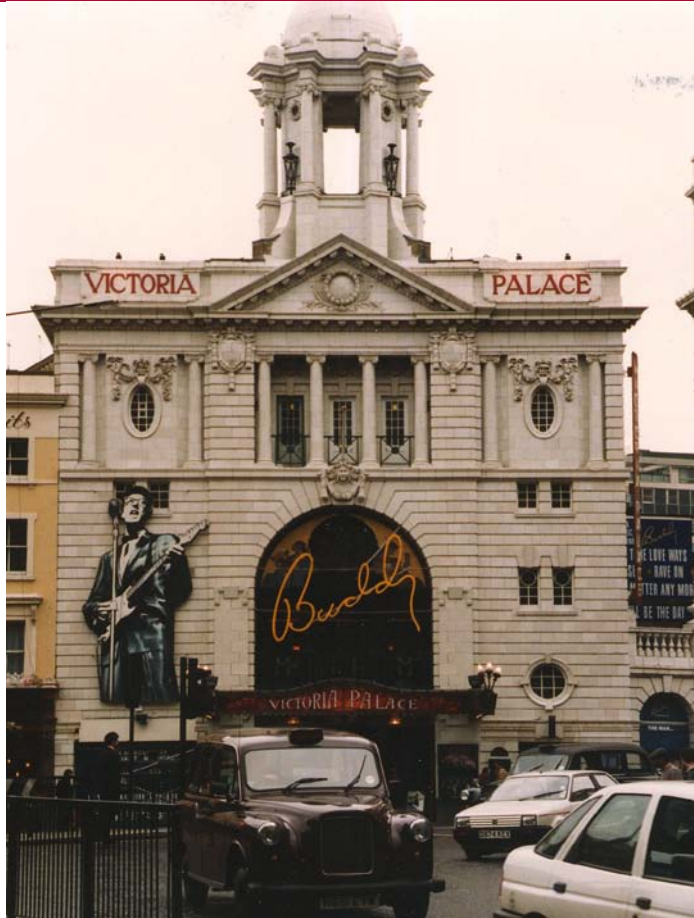
- The work entailed cleaning of cream faience followed by extensive repairs and restoration including repointing of joints, removal of ferrous steel fixings and replacement faience units.
- Where the glazed face of units had eroded a special hand applied simulated glaze coat was applied.
- The cupola structure originally included uncased structural steel ring beams that had rusted, expanded and lifted the faience masonry.
- This necessitated the insitu shot blasting of steelwork and additional material was fixed to strengthen the weakened structure which avoided the complete take down and rebuild of the structure.
- Scaffold access was of particular importance, as was the length of the working day as the show 'Buddy' remained in production during the contract.
